# Evaluation of underwater contamination by explosives and metals at Point Amour Labrador and in the Halifax Harbour area

Technical Report

DRDC Valcartier TR 2004-125

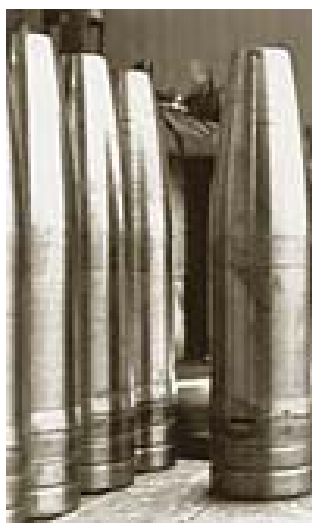
Figure 3. Projectiles Found Around the Wreck of HMS Raleigh

The underwater UXOs found around the wreck of HMS Raleigh were 7.5-inch projectiles containing mainly Lydite, TNT or black powder (see Figure 3, Annex 1), 3-inch projectiles, small arms munitions, Cordite etc. In order to safely dispose of these UXOs, high order detonation had to be achieved. This was evaluated through a test shot operation in May 2002 by using three 2-lb blocks of C4 on each projectile. The operation implied the destruction of fifteen projectiles, with pre- and post-detonation sampling. A control site was also designated for sampling, as a base of comparison for the contaminants dispersion.

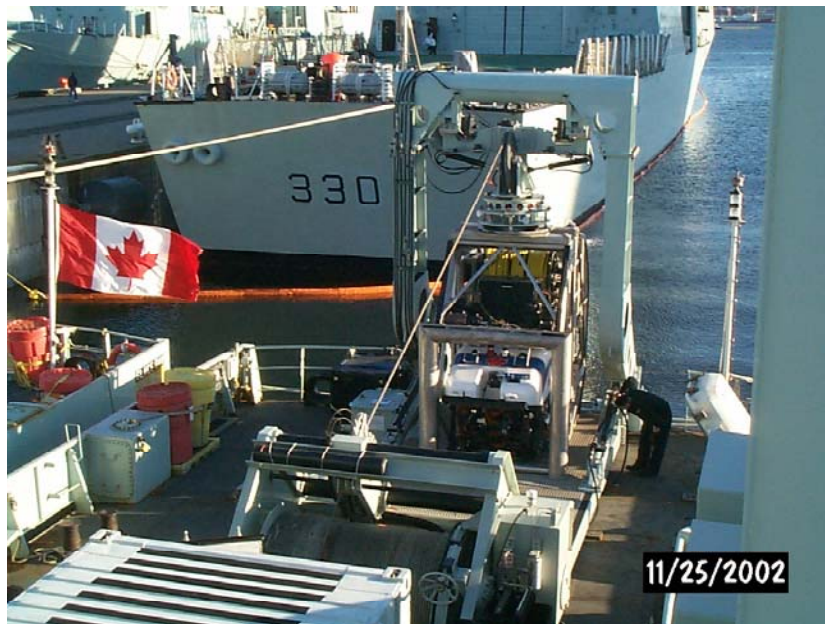
**Figure 4. Layout of DSIS on the Deck**

The sampling was done with the use of a Deep Seabed Intervention System (DSIS) carried onboard a Maritime Coastal Defence Vessel (MCDV) of the Canadian Navy. The DSIS is comprised of a Remotely Operated Vehicle (ROV) fitted inside an

aluminium cage. This cage was brought in the water by a motor-operated winch containing 1,000 m of cable. The ROV was deployed from the cage at short distance from the bottom of the sea and was connected via 250 m of tether. The submersible part of the system was controlled and monitored from a Control Van (CV). The ROV is fitted with 2 arms; one capable of 7 functions and the other, of 5 functions. Those arms were controlled from the CV. Follow-up was done by watching one of the camera displays in the CV. Figures 4, 5 and 6 in Annex 1 show the system and its layout.

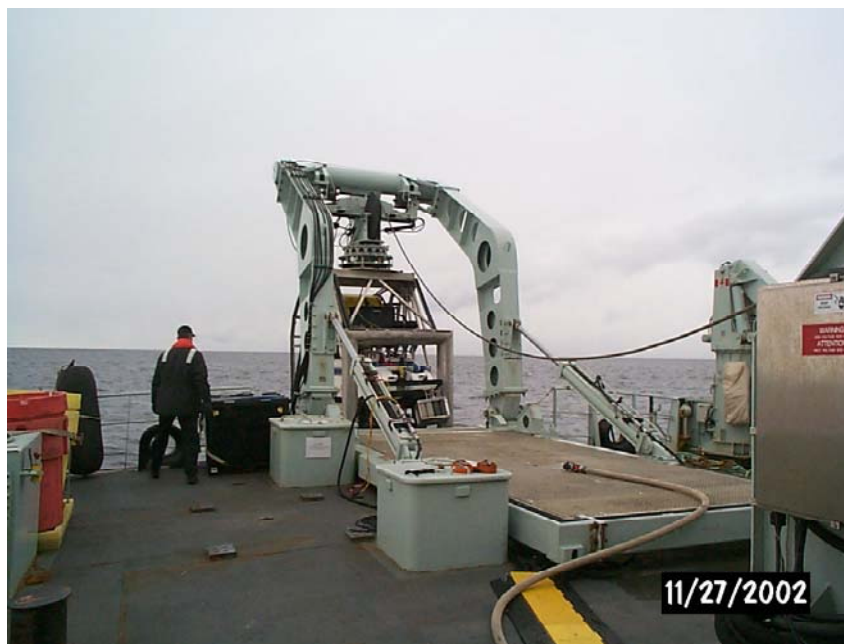
**Figure 5. Deployment of the ROV**

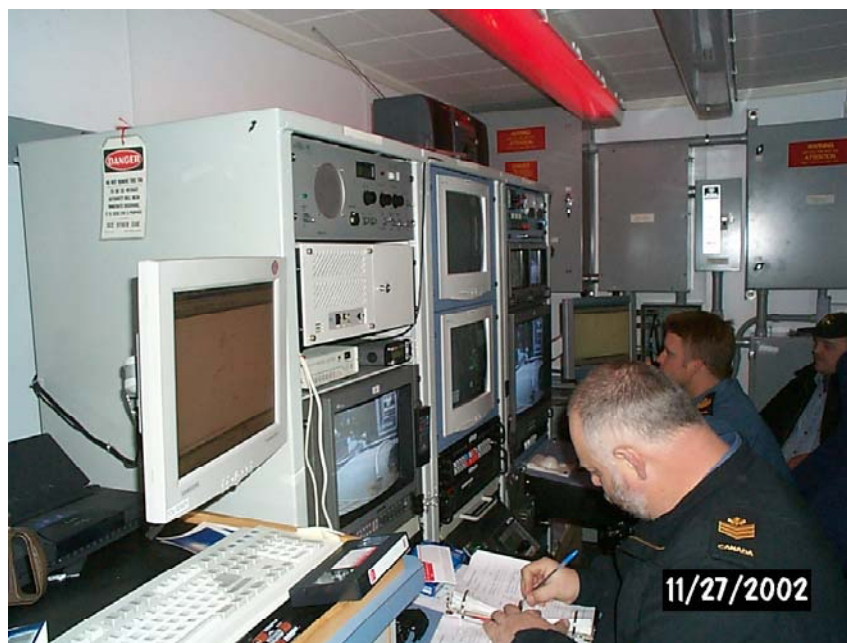
**Figure 6. Control Van**

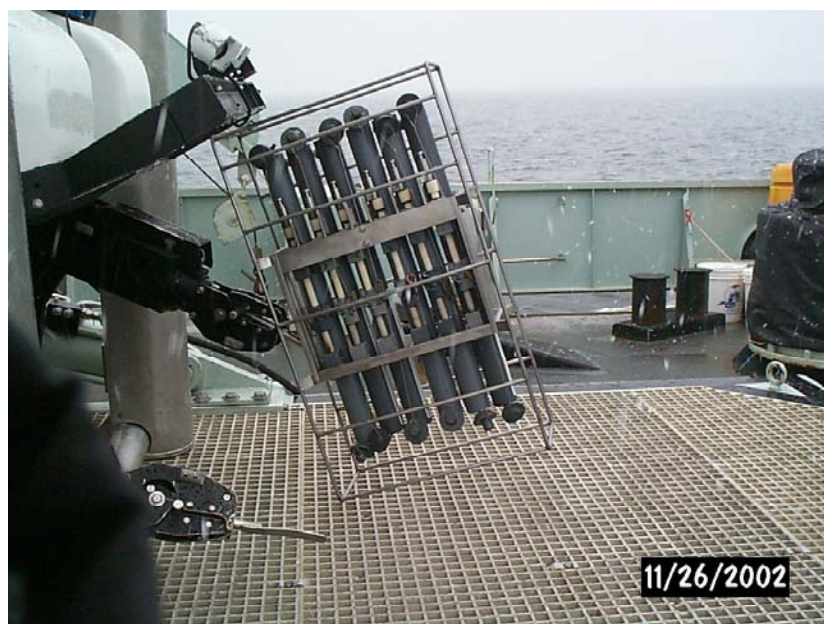
**Figure 7. Water Sampler**

Water sampling was done by using 6-ganged PVC bottles each containing 1.2 l. These bottles contain a cap at each end: they are joined together with an elastic rubber tube inside the bottle (see Figure 7, Annex 1). Before sending the sampler in the water, the two caps had to be manually opened and attached to the piston activator located at the middle of the bottle. The flush valve found at the bottom of each bottle also had to be closed and the pressure seal tightened. Once the sampling system was ready, the bottles were cleaned using acetone then rinsed with distilled water. Once cleaned, the sampling system was brought to the ROV, where one of the two arms could take it in its claw. The other arm of the ROV was fitted with an aluminum stick, which was used to activate the pistons of the bottles in order to capture the water inside. Sampling method originally consisted of taking a water sample at 4 cardinal points on a 50-m radius circle around the target, with at least 25% of random duplicates. Once the samples had been taken, the sampler was brought back onboard and the samples were split into portions for energetic materials (EM) and for metals analyses. The EM water samples were transferred into a 1 l amber glass bottle containing 1.5 g of sodium bisulphate. The metals water samples were transferred into a 250 ml plastic bottle containing 1 to 2 ml of a solution of 50% nitric acid. These bottles were stored in a cooler on the sweep deck during sailing, and then transferred in a refrigerator when back on land.

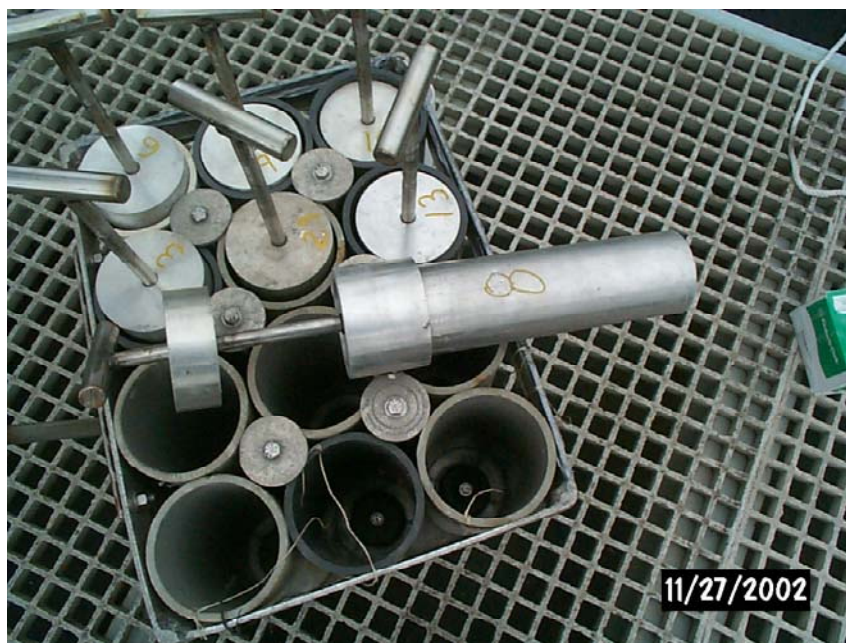
**Figure 8. Core Samplers**

For the sediment sampling, two methods were used, depending on the type of sample needed. The first method was core sampling, using aluminum tubes containing about 500 g. These core samplers were used to take samples at cardinal points around the target, in the same way as for the water samples. The core samplers were disposed in a rack containing PVC tubes with a rubber stopper at the bottom. Before fixing the sampler on the ROV, aluminum tubes were cleaned with acetone and nitric acid, and rinsed with distilled water between each cleaning step. The PVC tubes and rubber stoppers were cleaned with acetone and rinsed with distilled water. Once the sampler was back onboard, the samples were split into portions for energetic materials (EM) and for metals analyses transferred in plastic bags using a small metallic scoop, which had been previously cleaned according to the precedent description. The plastic bags were then stored in a cooler on the sweep deck, until back on land where they were transferred in a freezer. Since a large sediment sample was needed by BRI for microbiology study, a second method was developed to collect such a large sample. This second method used for sediment sampling consisted of scooping the bottom of the ocean with a large aluminum container, in order to fill a 20 l plastic pail. Interestingly, this unsophisticated method worked well and the plastic pail was easily filled with sediments. The container was also previously cleaned with acetone then nitric acid, and rinsed with distilled water between steps. Figures 8 and 9 (Annex 1)

show the sediments samplers for both methods. Once back onboard, the sample was simply transferred by pouring the content in the pail. The pail was then stored on the sweep deck for all the length of the study. Due to cold weather, the sediment sample in the pail slowly froze over the length of the trip. All samples were then shipped to Biotechnology Research Institute (BRI) in Montreal for analysis of EM and microcosm studies and, to a private laboratory in Halifax for metals analyses.

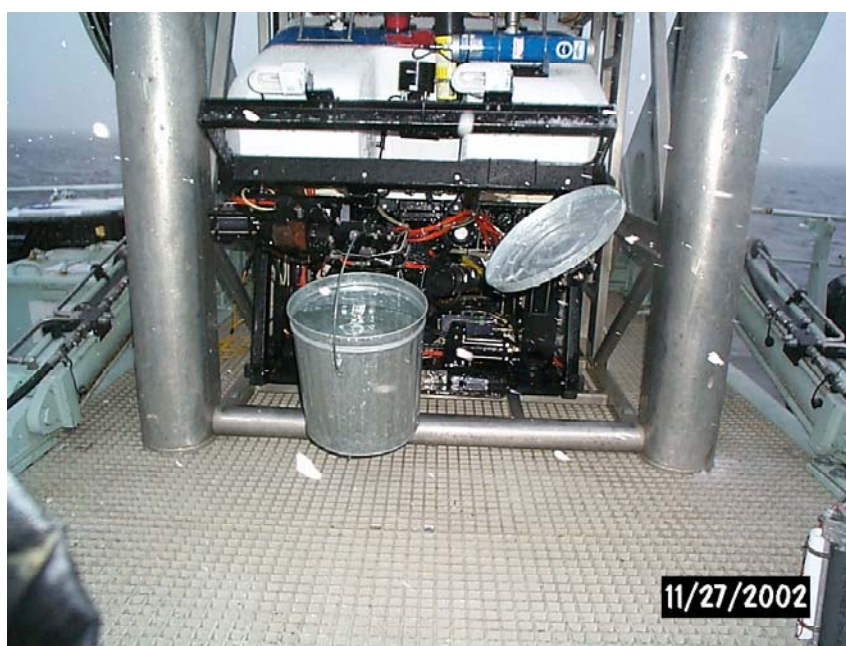
**Figure 9. Metallic Container Used for Scooping Sediments**
